Has your Horse been “X-ray Labeled” ?

Monique Craig
EponaShoe

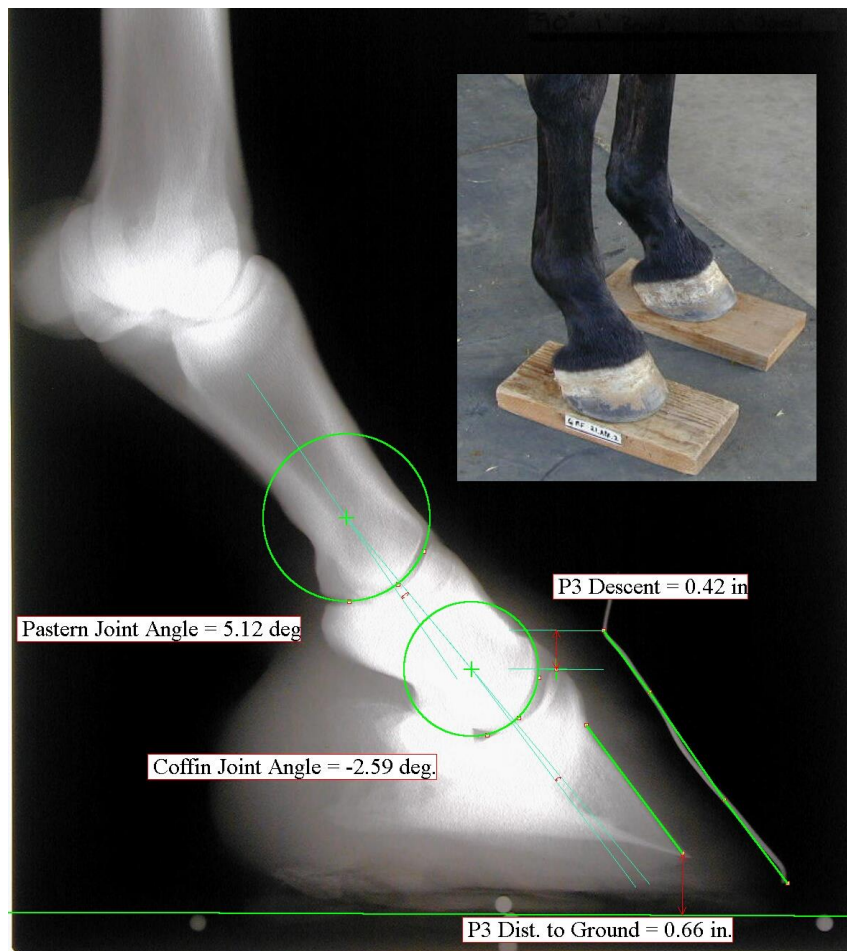
Figure 1

The quality of the exposure is obviously very important and the majority of veterinarians are well aware of this, but how about the hoof placement at the time of the x-ray? A radiograph can show significant differences depending whether the horse's leg is placed in front of the shoulder point or behind, and/or whether the hoof is bearing full weight or not – meaning that either the opposite leg is lifted off the ground or the x-rayed hoof is placed on a higher block. The lateral radiographs shown in figures 1 through 4 were taken the same day with two horses under different situations. Each image shows the actual x-ray and an inset photo taken at the same time of the radiograph. In figure 1, the inset photo shows this particular horse (Gloria) standing with both feet on a 1 ½ inch block.

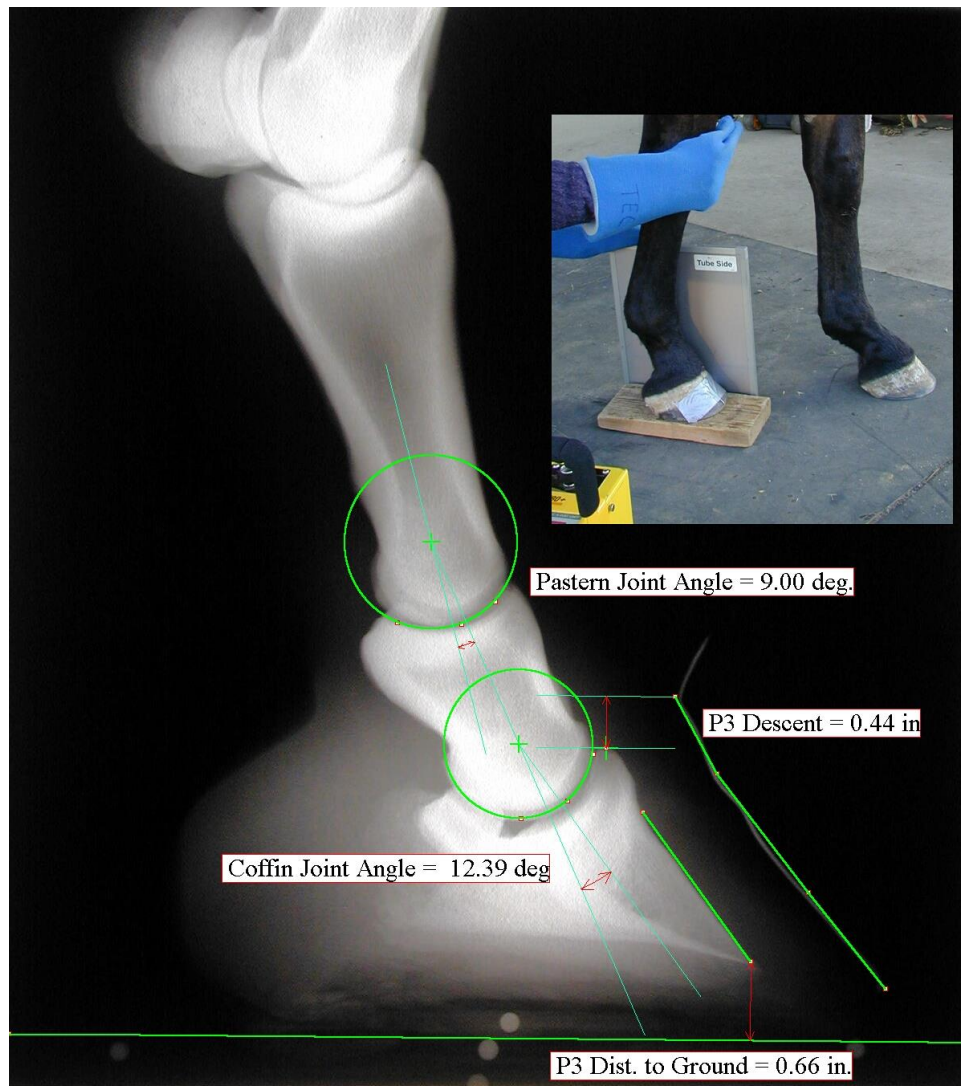
Figure 2 shows the x-rays of Gloria with her leg standing back while taking the x-rays. The horse may have moved and the practitioner was not careful to correct the stance of the horse.

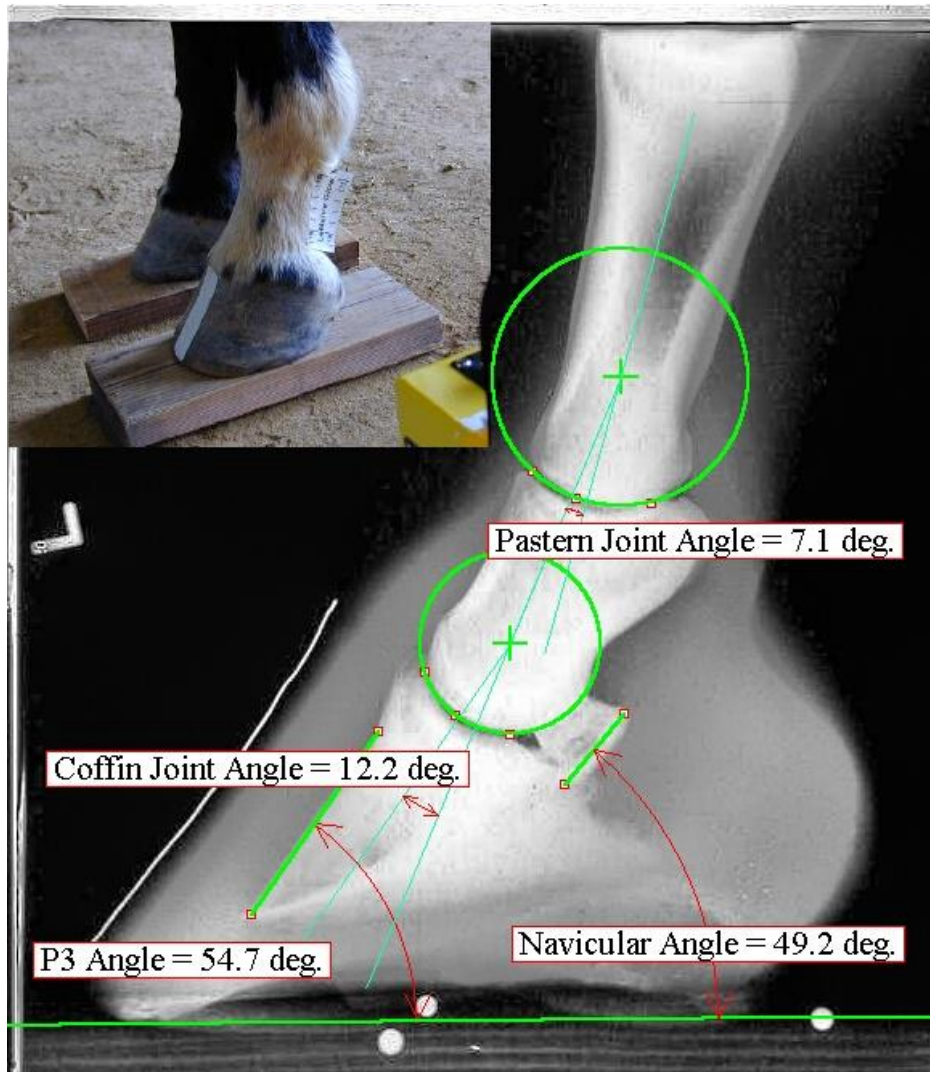
Figure 3 shows another horse (Gluck) standing with both feet on blocks of the same height at the time of the x-ray. Figure 4 shows the same foot when the opposite leg was lifted to “load” the x-rayed foot more heavily. This is to illustrate the differences that weight-bearing can make on the details of a radiograph.

It is hard to predict with certainty what the veterinary diagnosis would be of either of the two x-rays, but it is doubtful that the outcome would be the same. Perhaps in case of the x-ray in figure 4, a veterinarian may find the position of the navicular bone and the stress it creates in the deep digital flexor tendon worrisome. Your veterinarian may or may not decide to probe further (this depends on your pocket book too!) in this direction to find an answer to the lameness. He or she may advise you to change the shoeing to give more support at the heel and the sole! However, judging from the x-ray in figure 3, it seems that it would not be necessary and that the problem may lie somewhere else. So, a radically different conclusion may be drawn, simply because of how the horse was standing (and bearing weight) when the x-ray was taken.
